*Kennebecasis Watershed Restoration Committee
2009 Water Quality Monitoring Report*

*Prepared by Ben Whalen
February 2010*

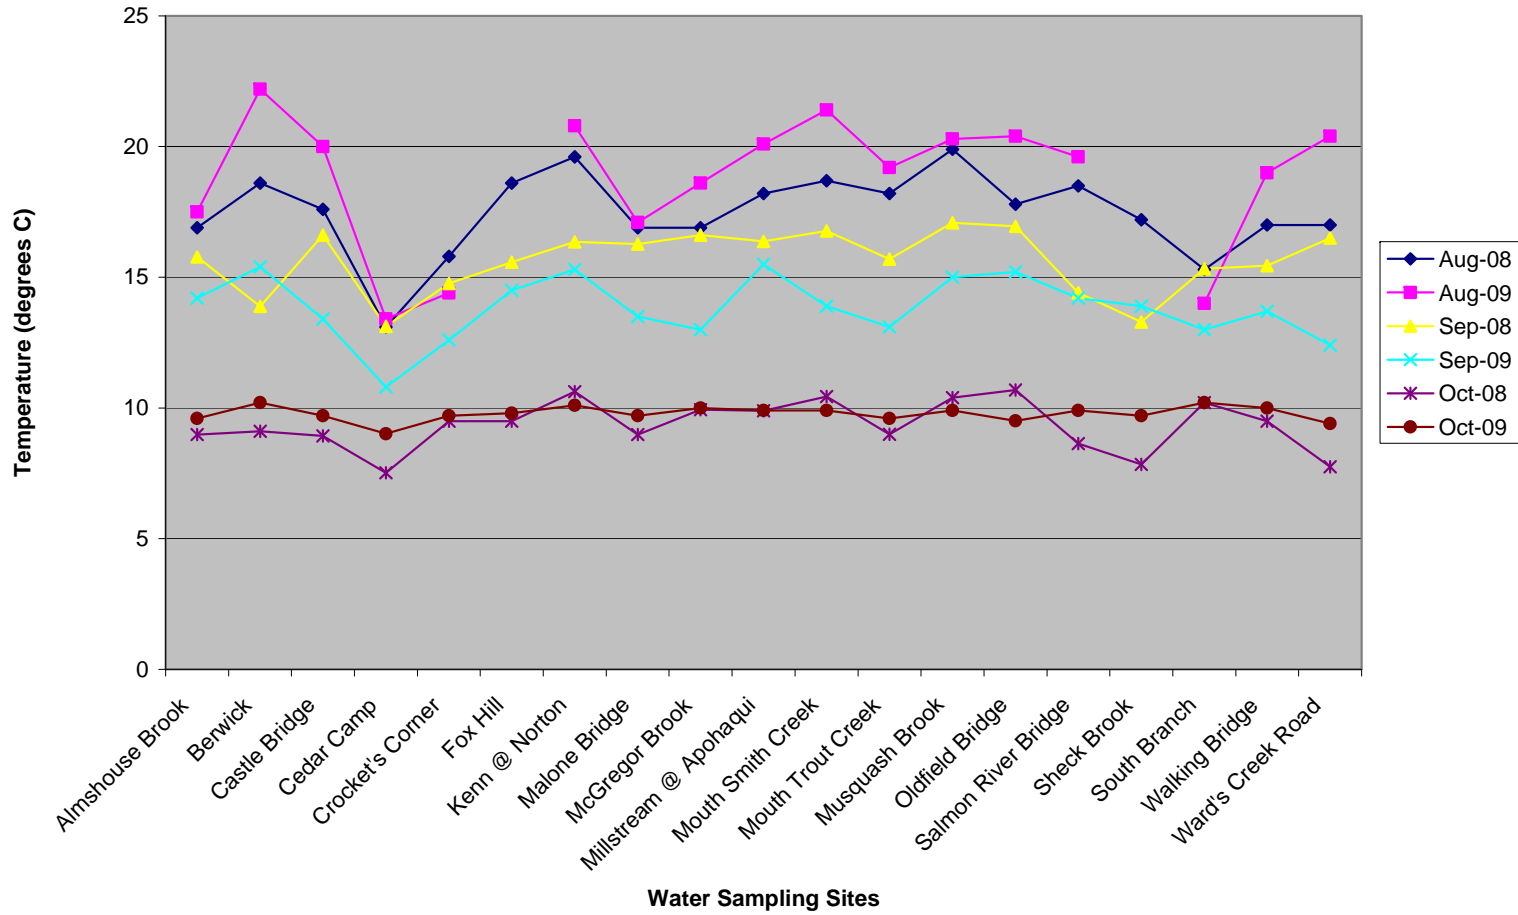
Water Temperatures: 2008 vs. 2009

No unexpected issues arose through the monitoring of DO and temperature through 2009. Data tables and charts in Appendix D illustrate the correlation between DO and temperature and this relationship exists nicely at all sites. A number of the sites have elevated stream temperatures in the summer months and this is cause for concern for fish health and water quality. A brief discussion on the results from each sub-watershed is below.
